**2002 California Freshwater Shrimp (*Syncaris pacifica*)  
Surveys Within Point Reyes National Seashore and  
Golden Gate National Recreation Area**

**February 2003**

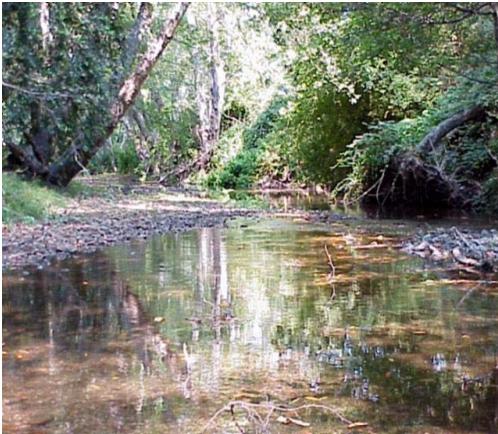
(Olema Creek, downstream view)  
Cr)

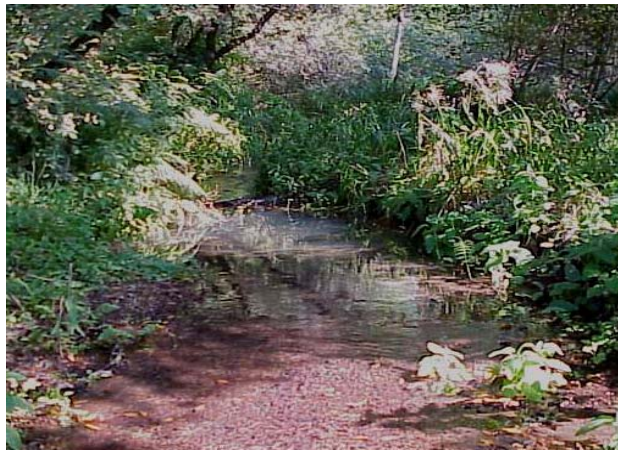
(Bear Valley Creek, upstream view)

This is a relatively undisturbed creek with mostly clear-running water. However there were sections with large amounts of silt and mud: Some of this condition existed in the area of the creek adjacent to the National Park Service maintenance yard, but also in undisturbed regions of the creek that were "clogged" with scour deposits, creating murkiness from riffle disturbances.

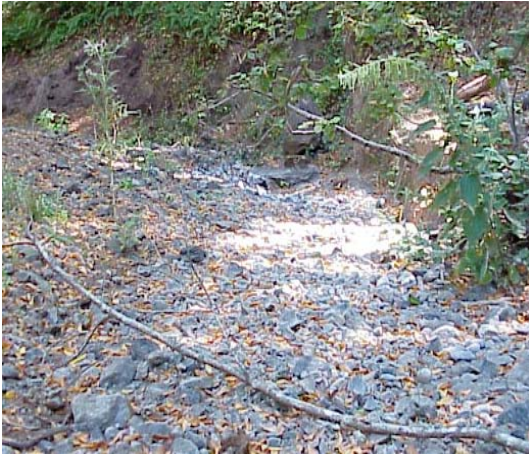
(Almost dry bed near the mouth of Zanardi)

The mouth of the creek was dry at the time of survey (not connected to Lagunitas Creek), and creek water was not found until an isolated pool was seen about 250 m from the mouth. From that point upstream was a series of isolated pools, from 6-8 m<sup>2</sup> in surface area, which became increasingly bigger and finally connected by slight trickles and riffle. A single cow was in the creek bed itself, and continued to move upstream as the shrimp surveying moved closer.

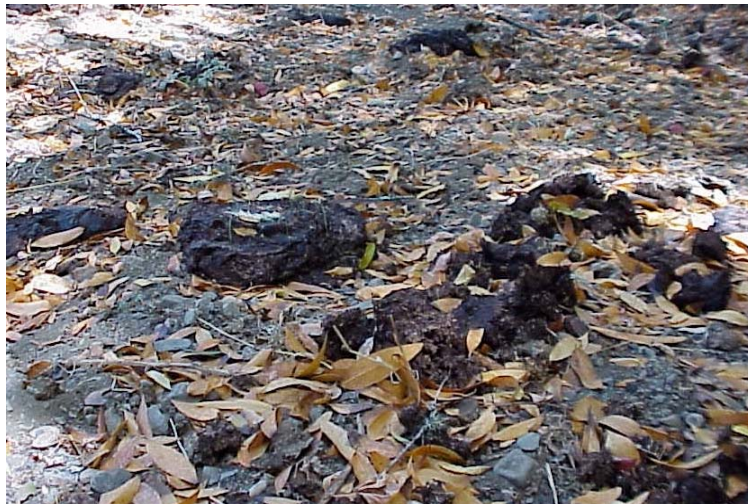
(Piles of cow manure found in the bed of Zanardi Gulch)

The overall habitat showed evidence of cattle impact. Manure was present in the creeks and broken fences were also evident along the north bank pasture bordering the riparian habitat. Rutted and eroded banks from cattle paths were seen at several points along the creek. Whereas the plant community is diverse and suitable to shrimp, the ephemeral nature of this creek, its orientation, and cattle presence suggest a lack of long-term suitability for shrimp inhabitation. Without cattle presence there would be a possibility for shrimp to survive within the deep pools of the lower section.

The remaining set of creeks being listed for consideration have reasonable potential for future shrimp habitat only if the surrounding environment is returned to an undisturbed state. These creeks include Cheda, Zanardi, and McIsaac. All three of these streams empty directly into Lagunitas Creek, the creek with one of the largest known populations of California freshwater shrimp. In addition, the shrimp populations found in Lagunitas are not far from its confluence with any of these three creeks (Serpa, 1998). Furthermore, because a shrimp was found in Cheda Creek only two weeks prior to this study, it is reasonable to infer that the shrimp

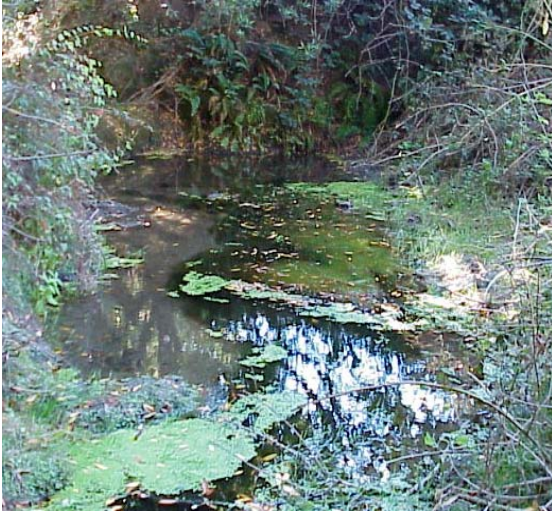
(Eutrophic water near cattle entry point, Cheda Cr. edge)

Intermittent sections of this creek contained large areas of eutrophic, algae and duckweed-covered pools. These algae laden sections were nearest to the eroded embankments of cattle travel. The creek water and surrounding dry bed was often littered with cattle manure. At the time of survey Cheda creek was observed to be rocky-bottomed pools connected by narrow trickles or riffle sections, on a gradual upslope in the upstream direction. Unlike the Zanardi property creek, Cheda Creek stays relatively flat for a longer stretch before the grade begins to increase upstream. It appears that water would move somewhat rapidly through parts of this creek, however there is more structural barriers (rock, debris and vegetation) positioned to support pool formation. The pool-to-riffle conditions at the time of the survey were 90 to 10%, which definitely could support the shrimp, but the expectation is that considerably less pool habitat would be present during the rainy season. Creek depth at the time of survey was 0.25m, and width was approximately 1.5m.

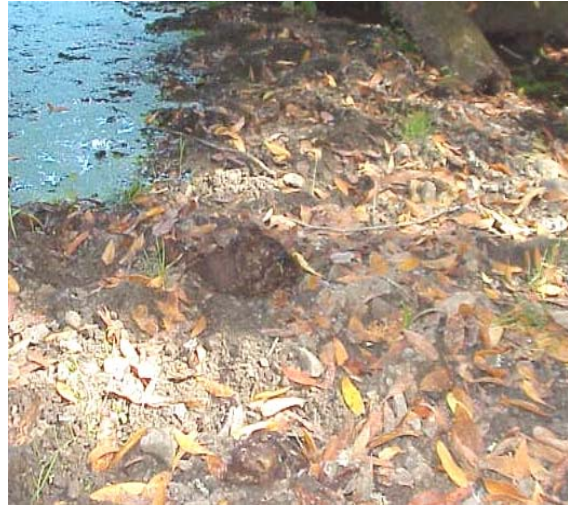
(Cattle hoof ruts and manure at Cheda Cr. edge)

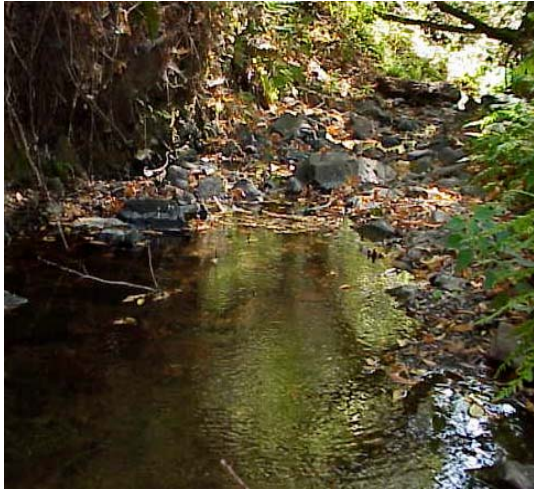
(Isolated pool in Mclsaac Cr)

Flows in Mclsaac Creek appears to drop greatly during the summer and fall season, when there is no runoff to feed the creek. The creek water itself and surrounding dry bed is littered with cattle manure and many parts have eutrophic slack water. Pipe, lumber, and household debris was half submerged in the creek, just below a residential unit at the cliff of the north embankment, approximately 500m from Sir Francis Drake Boulevard. At the time of survey Mclsaac creek was observed to be heavily receded, with rocky-bottomed interrupted pools, eventually connected by narrow trickles or riffle sections. Initially the creek was only gently sloped, then about 1/2 mile upstream there is a 6 foot high boulder structure and steep embankments. Although only a small fall was present at this rock wall during the survey, the physical structure of that section suggests a rapidly moving, large waterfall during the rainy season. Water would move somewhat rapidly through parts of this creek, however there are some structural barriers (rock, debris and vegetation) positioned to support pool formation. The pool-to-riffle conditions at the time of the survey were 98 to 2%, which definitely could support the shrimp, but the expectation is that the ratio would decrease greatly during the rainy season. Creek depth at the time of survey was 0.15m, and width was approximately 1.5m. Specific conductance was 0.4mS/cm throughout the surveyed section.

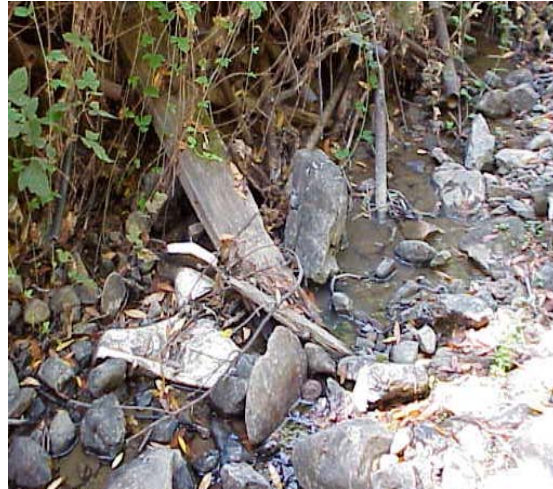
(Household debris & lumber dumped in Mclsaac)

Mclsaac Creek has a low water level in the dry season, and year-round pool habitat is sparse. The habitat showed a large amount of degradation due to cattle manure from cows grazing loose in and around the stream itself, pollution, and debris. Some broken fences were also evident along the north and south bank pastures bordering the riparian habitat, from which cattle trails had been made down to the creek itself. Deeply rutted and eroded banks from cattle paths were seen at many points along the creek. Beyond the cattle ranches the creek becomes much more pristine, but at that point the creek becomes steep and it is unlikely that shrimp would inhabit such areas. Whereas the plant community is diverse and suitable to shrimp, the cattle presence and pollution found in many parts of this stream suggest a lack of long-term suitability to sustain a population in the creeks present condition. It appears very unlikely that shrimp could be supported by the creek environment in its present condition.

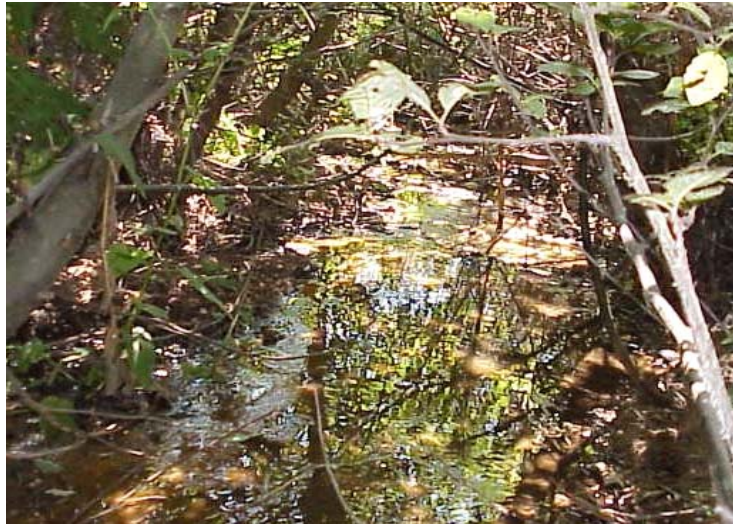
(Dense vegetative cover over Glenbrook Cr)

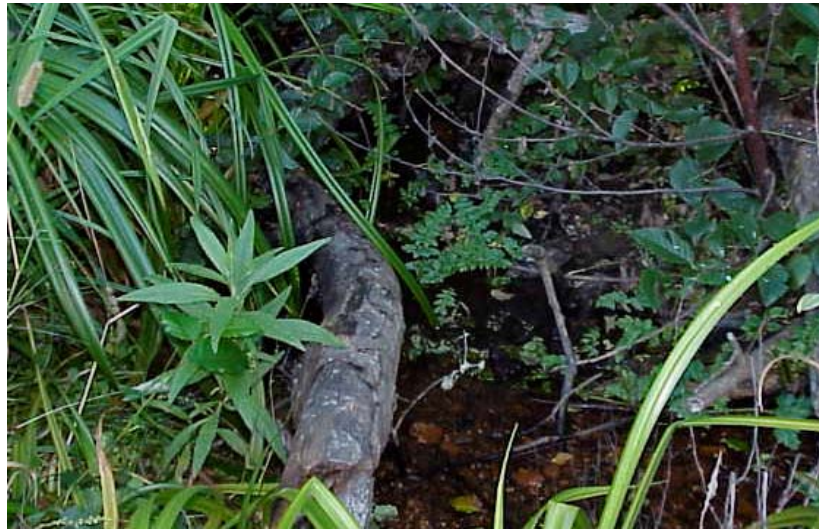
(Narrow portion of Muddy Hollow Cr)

puddles-or just damp ground-at some points were the only evidence of creek. Much of the surveyable water was stagnant, with an oily surface residue. This is almost an ephemeral creek in the lower reach. About a mile upstream from the marsh the flow is viable, but narrow and with no visible pools; it is almost total riffle upstream of the woodland habitat. Pool-to-riffle conditions in the lower reach were 99 to 2%, and 5 to 95% in the upper reach.

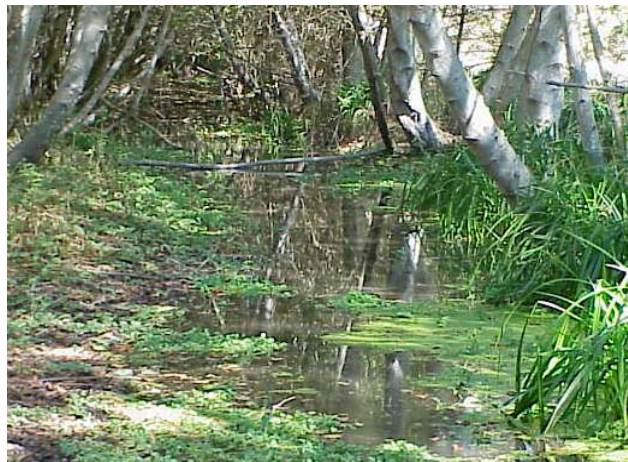
(Upstream view of Laguna Cr, just above the marsh)

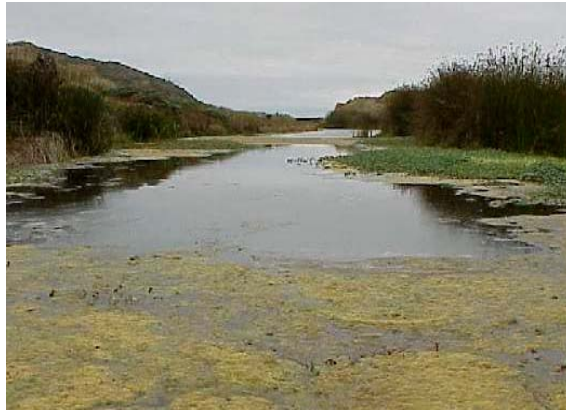
(The mouth of Kehoe Cr, near Kehoe Beach)

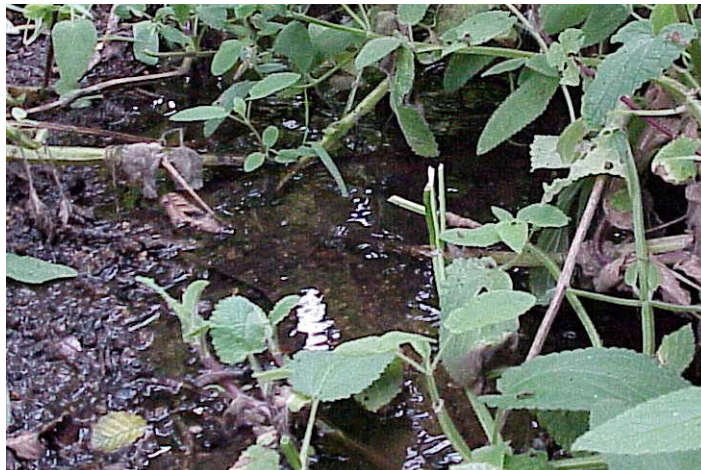
(Very shallow waters in upper section of Schooner Cr)

The creek water recedes appreciably in the dry season, and about half of the embankment height was not covered by water. The creek depth was greatest in the open lower reach, averaging 0.25m deep, and became much shallower upstream, averaging 0.3m. The creek is also much wider at the marsh end and narrows considerably upstream. The largest width measured was in the lower portion, at 1.5m, and the smallest width measured was in the upper portion, at 0.15m. Some portions of the creek through the woodland branched out into almost dry, dead-end flows. The flow conditions were difficult to assess overall, as a few sections of the creek could not be viewed through the dense vegetation, but in general the pool-to-riffle was 95 to 5% in the initial section, and approximately 75 to 25% above it. Whereas the lower section of the creek was mostly slack water with tidal flow, the upper portion had many sections of gentle riffle. Suitable pools for shrimp were very sparse. The upper section is silted and muddy-bottomed in areas closest to the Rogers Ranch grazing pasture. Areas of standing water with algae and slick residue were apparent at drainage points from the pasture hillsides. Specific conductance ranged from 1.0mS/cm (lower section) to 0.2mS/cm (upper section).

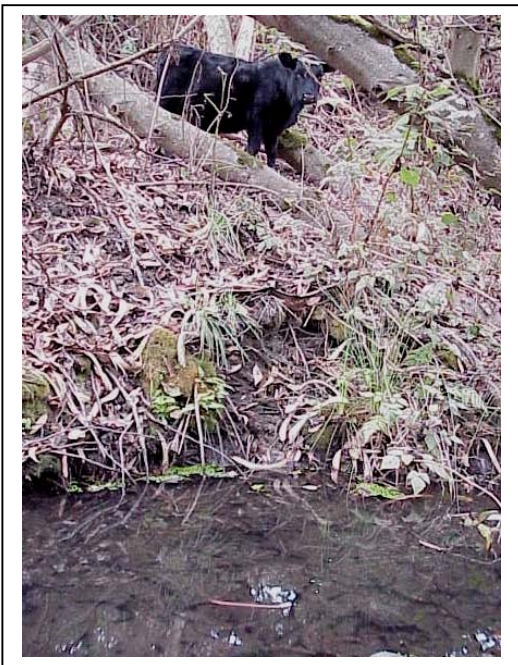
(A ranch cow loose above Home Ranch Cr)

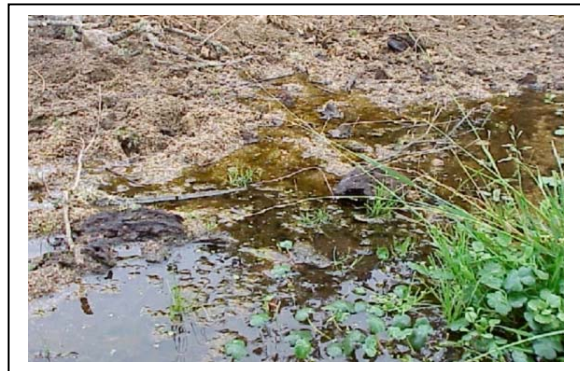
(HR Creek erosion & algae from cow ruts, manure)

fencing to protect it, thus the banks are rutted and have little vegetation in some places where typically it would be densely covered. The point where the creek runs under the farm road the water is covered by algae and pollution slick. Broken fence line and cattle trails were observed, as well as an escaped cow standing on the creek bank. But above the ranch the creek takes on a much different habitat, with excellent diversity of undercut/overhang and pool/riffle habitat. The water has a more pristine appearance, and the creek becomes undisturbed with deep banks. Although the lower portion of the creek is much too degraded to effectively support shrimp, the upper portion is still in excellent overall condition. The fact that no shrimp were found in any part of the creek could be that the lower portion is too damaged for shrimp to survive and colonize higher reaches, or that individuals may be in the upper reach in very small numbers. In its present overall condition, this creek does not appear to have suitable habitat health for the support of shrimp populations, but further surveying under improved conditions may be necessary to completely rule out this possibility.

Home Ranch Creek, like Cheda, Zanardi, and Mclsaac, is also much degraded in sections, and yet has some excellent upstream habitat with some potential for shrimp inhabitation only with a great deal of modification to the surrounding developed environment. The exclusion of livestock, along with the diversion of waste run-off away from the creek, must occur for the possibility of future shrimp presence.

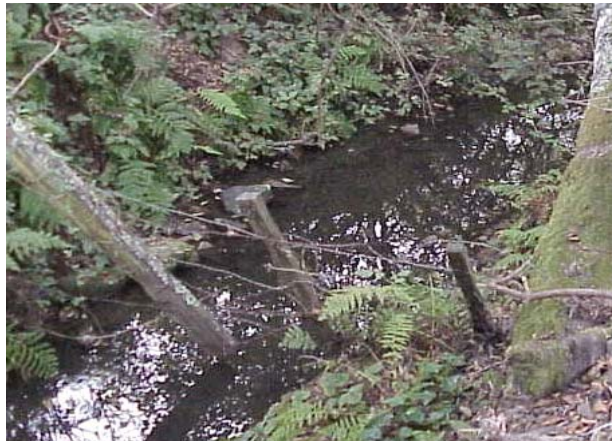
(Upper section of Home Ranch Cr, above ranch)

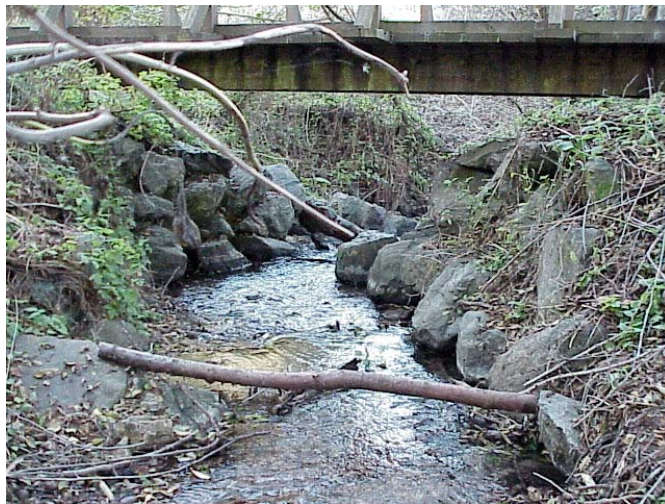
(Downstream view of Coast Creek below Coast Trail bridge)

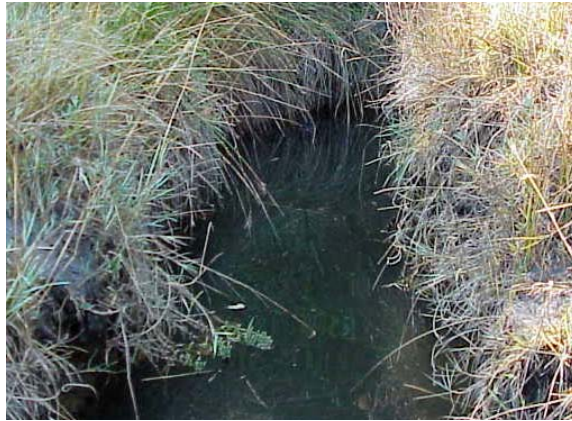
(View of Shell Beach Creek near the mouth)
